TECHNICAL NOTE 4263

EFFECT OF PRIOR AIR FORCE OVERTEMPERATURE
OPERATION ON LIFE OF J47 BUCKETS EVALUATED
IN A SEA-LEVEL CYCLIC ENGINE TEST

By Robert A. Signorelli, James R. Johnston, and Floyd B. Garrett

Lewis Flight Propulsion Laboratory
Cleveland, Ohio

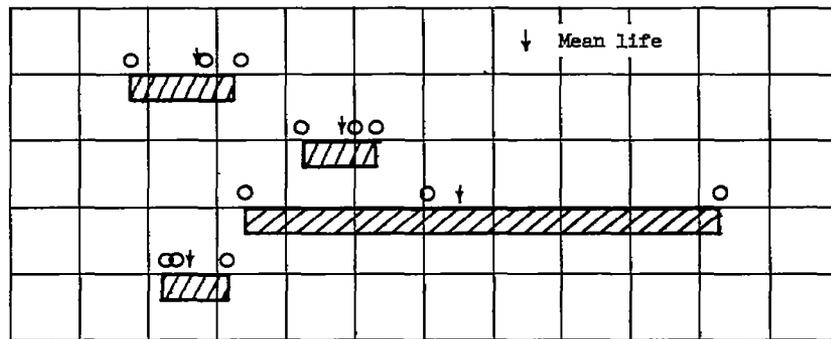
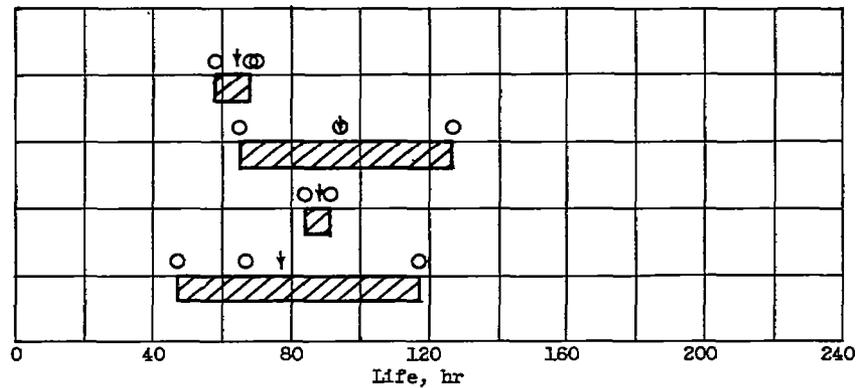
(b) Engine A. Temperature, over 1800° F (tailpipe) on acceleration.

(c) Engine B. Temperature, over 1500° F (tailpipe); engine overspeed, 104 percent.

Figure 11. - Stress-rupture results of specimens from bucket airfoils. Stress, 23,600 pounds per square inch; temperature, 1500° F.

Stress-rupture results. - Stress-rupture lives of specimens cut from the airfoil of buckets of each group are shown in figure 11. All specimens were tested at 1500° F and 23,600 pounds per square inch, which are the conditions for a nominal life of 100 hours for standard S-816 alloy bar stock. Stress and temperature conditions in a range corresponding to that in buckets during the engine test were not used, since the life of specimens would have been too long. For example, at a point 2 inches above the base of the airfoil, which is in the zone where stress-rupture life of buckets is at a minimum, bucket centrifugal stress is about 10,400 pounds per square inch and bucket temperature is about 1470° F (fig. 1). Stress-rupture life at these conditions is of the order of 30,000 hours for S-816. The mean stress-rupture life of specimens from standard S-816 buckets was 94 hours, which is reasonably close to the nominal 100-hour life for bar stock. The as-overtempered groups had shorter stress-rupture lives than the standard group, with mean lives of 54 and 64 hours for groups 1 and 5, respectively. The test bars from the fully reheat-treated groups showed an improvement in life over the as-overtempered group bars; this indicated some recovery of stress-rupture properties. The mean lives of 86, 130, 94, and 88 hours are about equivalent to the standard group. The as-overtempered and

As noted in the results, the stress-rupture properties of the various groups differed appreciably. The stress-rupture life of specimens from as-overtemperated buckets and overtemperated and aged buckets was lower than that of standard-bucket specimens (fig. 11). This might be expected because overtemperature exposure can reduce stress-rupture properties of S-816 alloy, as has been shown in the laboratory and engine studies (refs. 2 and 3).
